Sega Pinball Inc. © 1999 Technical Service Bulletin 112

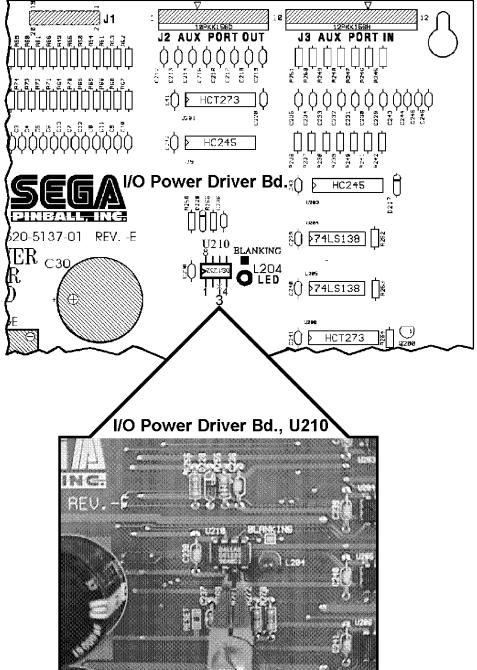
The location of the **U218 DS1232 I.C.** on the **CPU/Sound Board** is located in the *upper right area of the board to the left* of "SW200" Push Reset Button (see the Figure). **Pin-3** on **U218** is along the Right Side, 2nd from the Top. The location of the **U210 DS1232 I.C.** on the **I/O Power Driver Board** is located in the *upper right area of the board, to the left of LED* **204**.

We have found that by **CLIPPING Pin-3** of the **DS1232** which increases the tolerance to 10% (4.5v) we are able to eliminate the reset condition without creating other problems such as gliches. In some cases, this will not fix the problem due to other problems such as too many games plugged into one multi-strip outlet without a ground prong or any number of hardware and software problems.
