Nº 127 SERVICE BULLETIN

SUBJ: Plastic Stadium Flashlamp Removal

STRIKER XTREME &

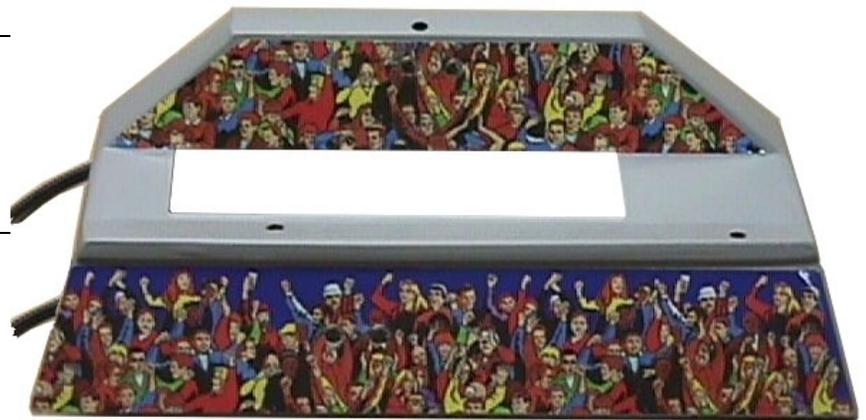
Fig. 1

The Stadium Plastic Cover (**Fig. 1**) begins to *distort and/or melt* at the top from heat build-up (generated by the flashlamps).

We have received a few calls from distributors and operators complaining that the Stadium Plastic Cover is becoming damaged from the heat generated from the flashlamps inside. The **top two** (2) flashlamps (*which are riveted inside of the assembly*) may move due to vibration depending on how snug the rivet is. When the bulbs move too close to the inside surface of the stadium, *they may cause heat damage*. As the material softens over time, the plastic may distort (or melt).

Remove the top two (2) #906 Wedge Base Bulbs (**Fig. 2**). *This will not adversely affect gameplay and will **guarantee** that this problem will not occur.*
