Nº 135 SERVICE BULLETIN

SUBJ: <u>OPTIONAL</u>

Ramp Butyrate Fix Kit (SPI: 502-5012-00)

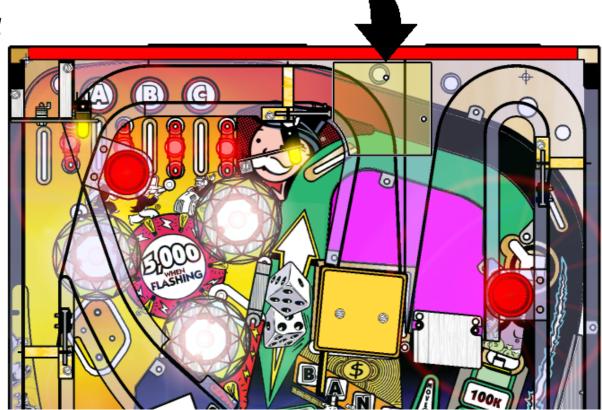
Some **playfield shots** (from the flipper) into the *open Bank Door*, up the Center Ramp, tend to "loft" and hit the Center Ramp Entrance Gate Bracket *or* may lodge behind the *"Free Parking Sign."* If it hits the Gate Bracket, it causes the ball to be returned down the ramp, unable to complete the shot.

Locations with a *higher than normal* Line Voltage, may see lofting due to the *increased strength* of the Flippers. If you're experiencing the above symptom, the following *OPTIONAL Kit* may be purchased through your distributor.

Attach the new *Clear Plastic (Butyrate) Piece* over the ramps as shown in the graphic below. This *Clear Plastic Piece* is included in the <u>OPTIONAL</u> MONOPOLY® RAMP BUTYRATE FIX KIT (SPI: 502-5012-00), along with this Service Bulletin 135 (SPI: 756-5012-00), #6 X 1/2" PTH A Screws (Qty. 2) (SPI: 237-5809-00) and Clear Plastic (Butyrate) Piece (Qty. 1) (SPI: 830-5995-00).

Step 1: Line up the new Clear Plastic (Butyrate) as shown and mark the 2 holes. Using a 3/32" Drill Bit, drill the 2 holes.

Step 2: Using the 2 screws, affix plastic.
