Nº 139 SERVICE BULLETIN

I/O Power Driver Board

SUBJ: F21 (50vdc) Fuse Blows Intermittently, System Checks OK on

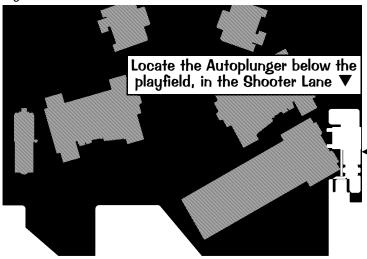
AUTOPLUNGER

The game will not serve the ball into Shooter Lane. After checking the fuses on the I/O Power Driver Board, the F21 Fuse (3A 250v Slo-Blo) is found to be blown. The fuse is replaced and everything works properly until the fuse blows again within a period of 1 week to a month or more.

The type of coil used for the Autoplunger is a **23-700** (Coil #**Q2**). This is a relatively powerful coil and uses more current then most other coils on the playfield. *In certain locations where line voltage is much higher than normal and you have skilled players that achieve many Multiball features the fuse can fatigue and blow.*

Replace the Autoplunger Coil with a **24-940** Type Coil (SPI Part Number 090-5036-00T). This coil has enough power to launch the ball into play, but will not fatigue or blow your fuse.
