Service Bulletin: SB 50

GAME: Whitewater

SUBJECT: Intermittent or weak action from ball popper assembly A-15769

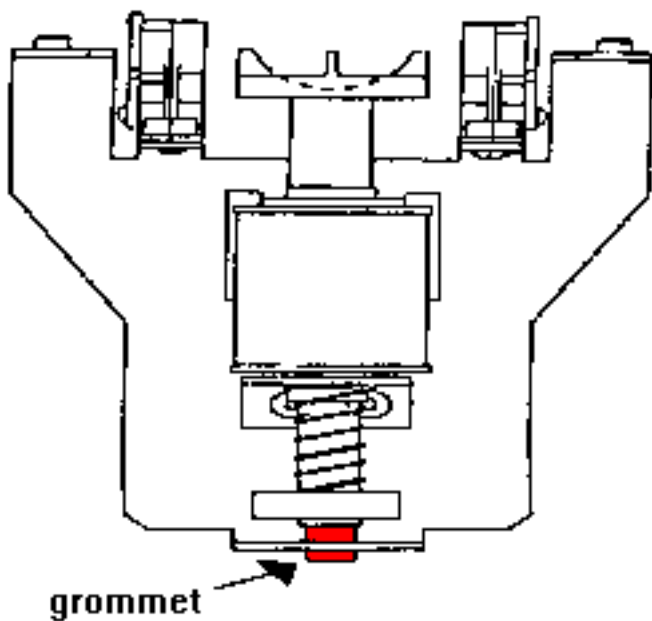
CAUSE: Rubber Grommet missing or installed incorrectly on ball popper assembly

We have had a few customers reporting that the rubber grommet (part #23-6420) on the ball popper assembly of "**Whitewater**" pinballs have been missing. See the diagram below for the location of the grommet. Please check your game and install a new grommet if needed.
