MM 1700-1  
July, 1976

# **STANDARDIZED TEST PROCEDURE FOR MIDWAY'S PROCESSOR BOARDS**

**MIDWAY MFG. CO.**

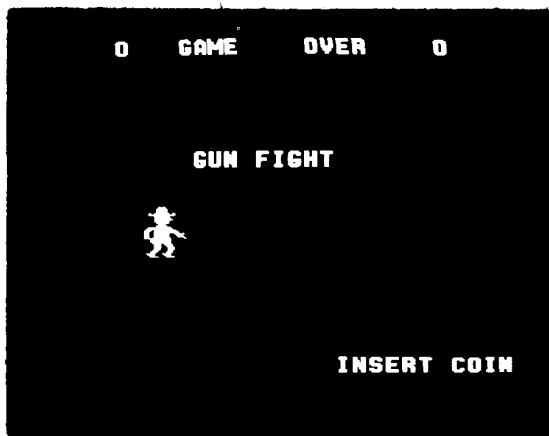
Figure 3.2-1 Good Picture with Good Program

By good picture is meant here a clear screen with the words "Game Over" and "0" on either side of it. In the case of a good Mother Board the words "Gun Fight" would be seen followed by the Cowboy coming in, shooting a bullet downwards, and walking back. During this process the words "Insert Coin" would appear on the lower right hand side temporarily (Figure 3.2-1). If all or part of this is bad it could most likely be a program problem.
